# Manhole Inspection Summary

Manhole # S37A2\_013MH

Insp Date: **11/8/08 12:31 PM**

**Location** Address: **4015 2nd St**

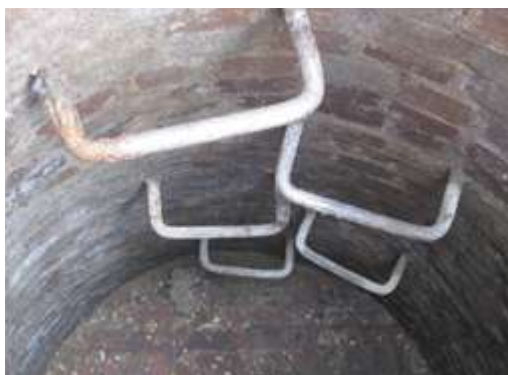
Steps

Count: **5** Missing: **0** ☐ Corroded

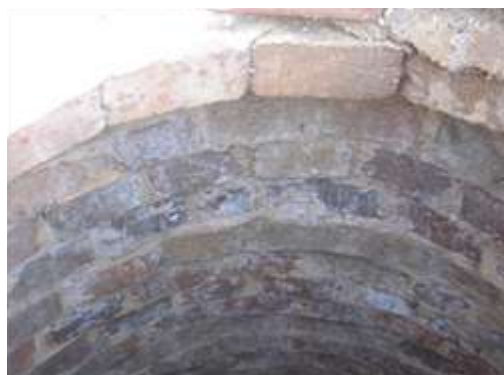
Defect 2

Infiltration: ☐ None ☒ **Joint** ☐ Cracks ☐ Mortar ☐ Roots ☐ Wall

Infiltration

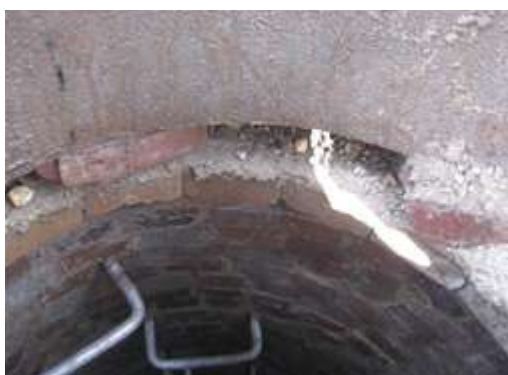
Defect 1

Condition: ☐ Sound ☐ Cracked ☐ Root Intrusion ☒ **Loose Brick** ☐ Deteriorated

Deteriorated Frame-Chimney joint.

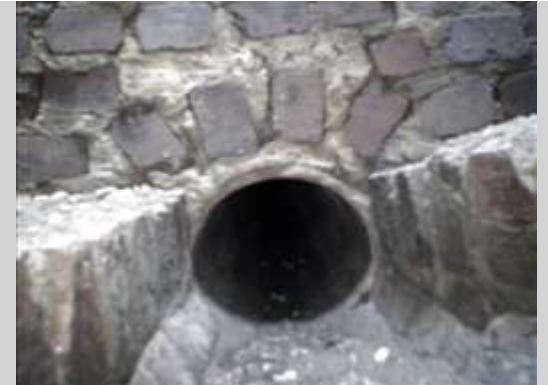
12 O'Clock Outflow

8 in. Circular Gravity Sewer  
Pipe Out @ 12 O'Clock

Pipe Height: **8.4** (in.) Rod and Bar (Angled)  
Pipe Material: **Unknown** ☐ Pipe Lined  
Invert Depth: **8.86** (ft.) Flow Characteristics: **Slow**  
Deposits: ☒ None ☐ Mud ☐ Sludge ☐ Debris ☐ Grease  
Silt Depth: (in.) Deposits Extent:  
Infiltration: **None** Pipe Seal Cond: **Sound**

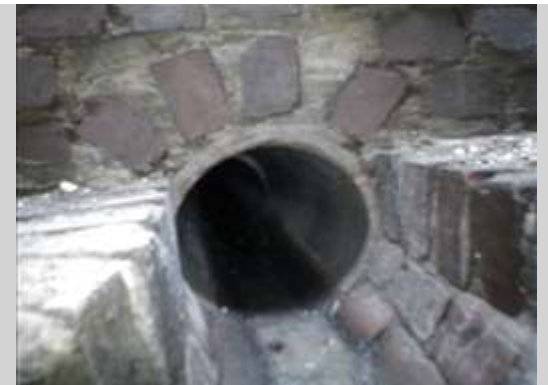
3 O'Clock Inflow

8 in. Circular Gravity Sewer  
Pipe In @ 3 O'Clock

Pipe Height: **8.4** (in.) Rod and Bar (Angled)  
Pipe Material: **Unknown** ☐ Pipe Lined  
Invert Depth: **8.58** (ft.) Flow Characteristics: **Slow**  
Deposits: ☒ None ☐ Mud ☐ Sludge ☐ Debris ☐ Grease  
Silt Depth: (in.) Deposits Extent:  
Infiltration: **None** Pipe Seal Cond: **Sound**

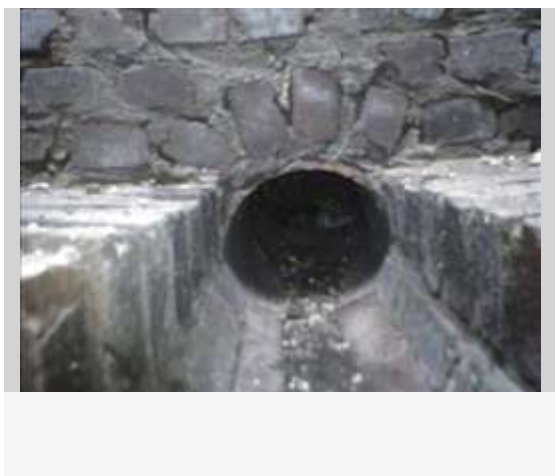
6 O'Clock Inflow

8 in. Circular Service Sewer  
Pipe In @ 6 O'Clock

Pipe Height: **8.4** (in.) Rod and Bar (Angled)  
Pipe Material: **Unknown** ☐ Pipe Lined  
Invert Depth: **8.74** (ft.) Flow Characteristics: **None**  
Deposits: ☒ None ☐ Mud ☐ Sludge ☐ Debris ☐ Grease  
Silt Depth: (in.) Deposits Extent:  
Infiltration: **None** Pipe Seal Cond: **Sound**
